COUNTRY USSR (Leningrad Oblast) REPORT  25X1

SUBJECT Warship Construction at Leningrad DATE DISTR. 1 August 1956 25X1

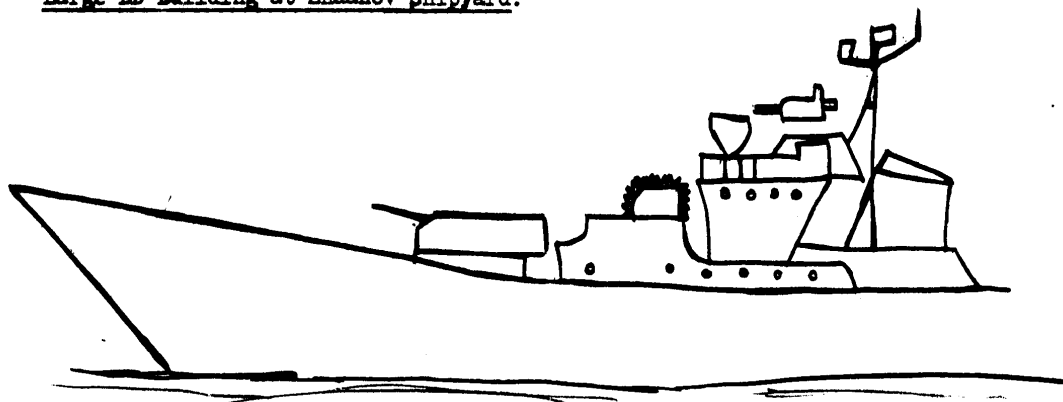
Sketch No. 1:

1. At the Zhdanov Shipyard there were two large flush-decked destroyers in the yard's basin. They had strongly falling stems, marked sheer, and one gun turret on the foredeck. Aft of the gun turret was a raised section covered with an apron. On the forward edge of the bridge was a round, apron clad device, a large main-battery director, together with a tripod mast forward of the stack. The ship was partly obscured from midships by the hull of a merchant ship. An after tripod mast with a large radar screen was observed forward of the top of the after stack, which was obscured. There was a large distance between stacks. There was no anchor in the hawse-hole. The ship was painted gray.  25X1

Large DD Building at Zhdanov Shipyard:

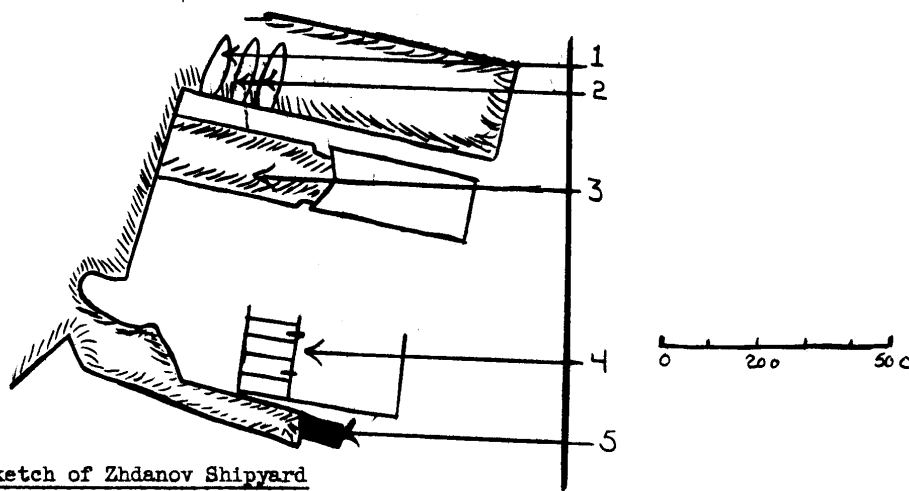
Sketch No. 2:

Sketch of Zhdanov Shipyard

1. Hull of merchant ship
2. Two large destroyers being fitted out
3. Basin with water up to the doors of the building
4. Wall with four large doors
5. Two slips with ships under construction

- (See sketch No. 1.) 25X1
2. In the basin under the large traverses in the Zhdanov Shipyard, the water extended up to the doors of the newly lengthened building that is located east of the basin. There were four large doors in the west wall of the yard's shed in the southern part of the area. The northern and southern doors were open. Traverses were visible in the roof. The forward section of a ship was being moved out through the south door onto the slip outside. Two ways were observed south of the yard shed. The hull of a ship with plate sides built to a height of 2 or 3 meters stood on one of them. On the other was a ship  judged to 25X1

- to be a minesweeper. One stack was mounted. (See sketch No. 2.)
3. At the Marti Shipyard there was the stem of a ship that stood behind a fenced area. The distance between the stem and the fence was estimated to be 20 meters. The stem was falling. A triple gun turret was observed on the foredeck. The caliber was estimated to be at least 15 cm. The vessel had a low superstructure. A main-battery director was located amidships. It was round and had a diameter that was estimated at 7 or 8 meters.  the height of this main director 25X1
